# Inspection Report

## Property Address:

ABC Dr

Brampton,On L6R0E7

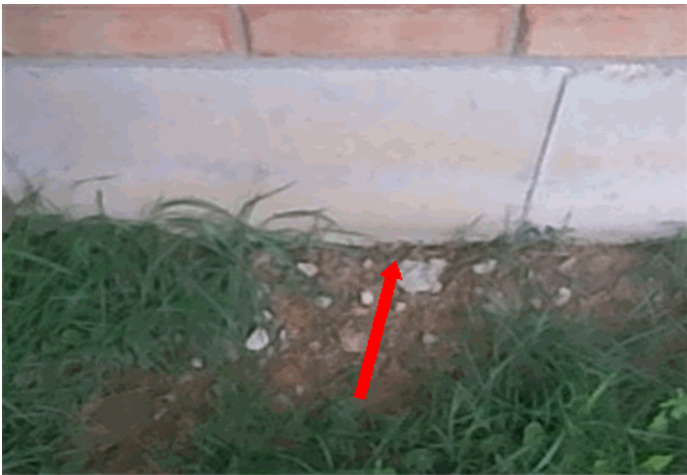
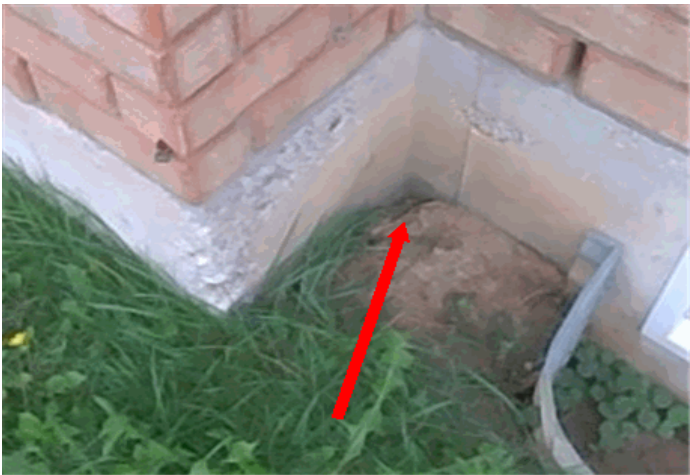
1) Grading Conditions

Poor grading near the foundation was observed . We recommend re-grading to assure all water drains away from the home's foundation. Failure to re-grade low-lying areas at the foundation can cause water seepage under slabs, into the basement / crawlspace, and / or cracks or movement in the foundation.

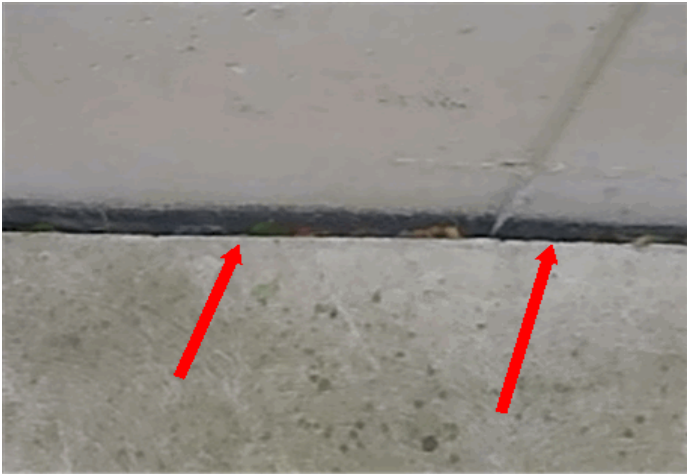
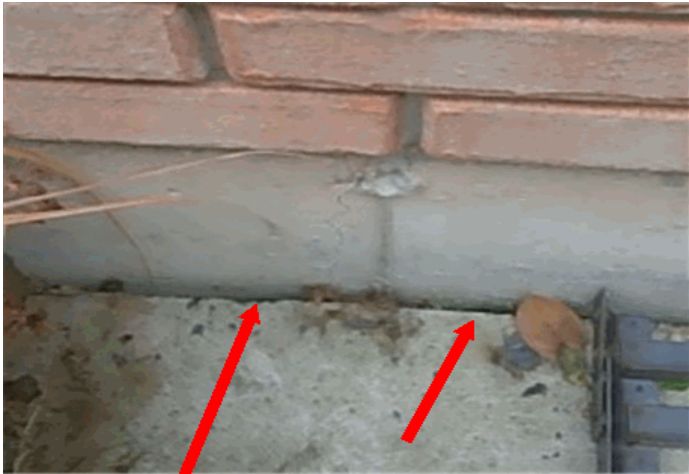
3) Sidewalk Conditions

Gap along walkway at foundation should be repaired with an appropriate concrete caulking to help direct water away from foundation.

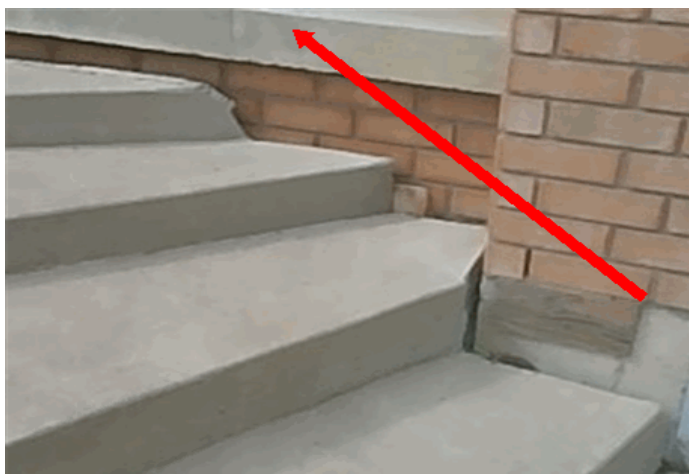
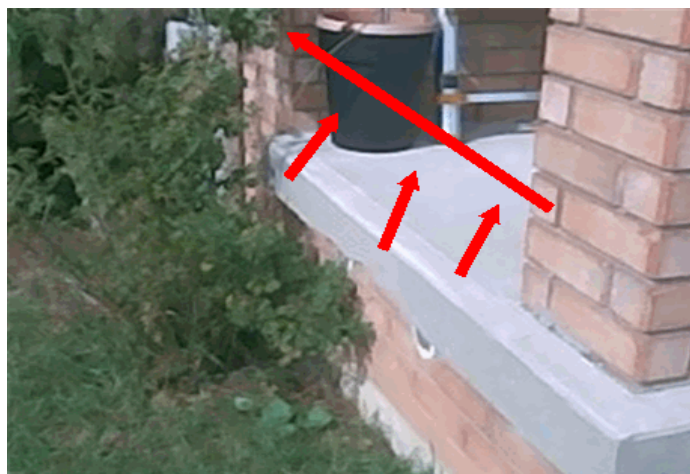
6) Front Entrance Conditions

No railings were present at porch and steps. For increased safety, client should consider installation of a railing. Client should consult with a qualified contractor for information on current standards.

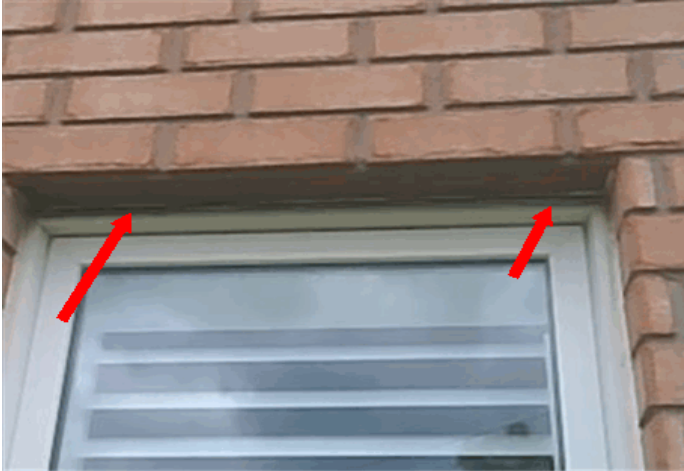
**9) Window Conditions**

The exterior windows caulking, putty and glazing compound was cracking with some deterioration observed.

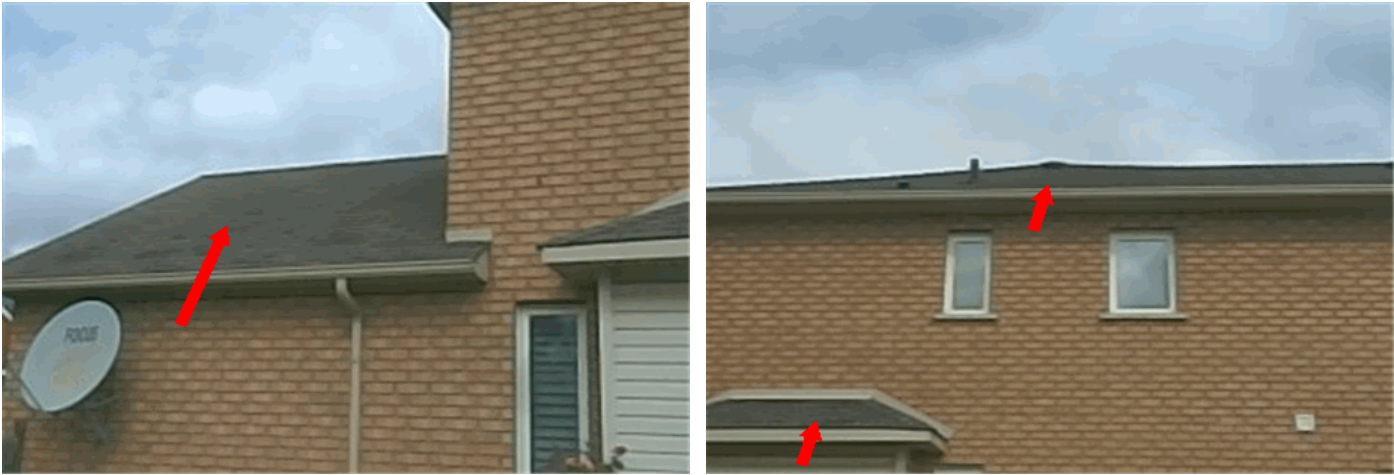
15) Roof Covering Condition      **RR**      The roof covering showed signs of cracking, curling, and loss of granules. This condition generally indicates that the roofing materials are approaching or close to the end of their useful life. Replacement is most likely needed. The inspector cannot offer an opinion as to whether the roof leaks today unless it is moderately raining at the time of inspection. We recommend further evaluation by a qualified roofing contractor prior to close. Client should obtain full disclosure / history information from the seller prior to close.

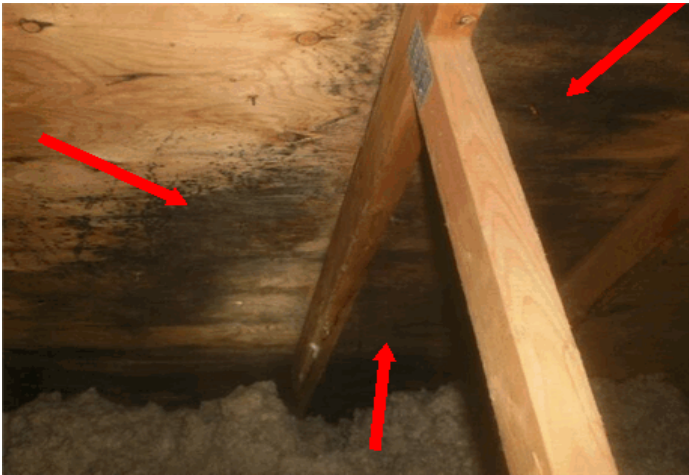
<b>21) Attic Conditions</b>	<div><b>RR</b></div> Evidence of suspected mold was observed at attic. A mold inspection or testing was not performed as part of this general home inspection. Client is advised to consult a qualified mold testing company prior to closing.
-----------------------------	--

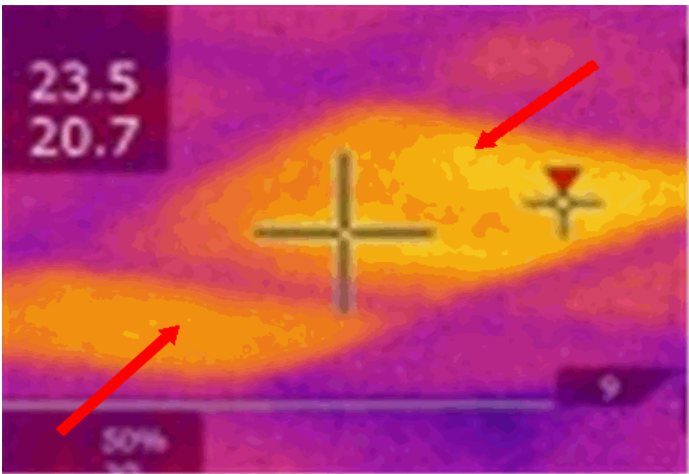
<b>22) Attic Insulation Conditions</b>	<div><b>RR</b></div> Compared with today's standards, the amount of insulation was too minimal at some areas detected with infrared camera..
--	--

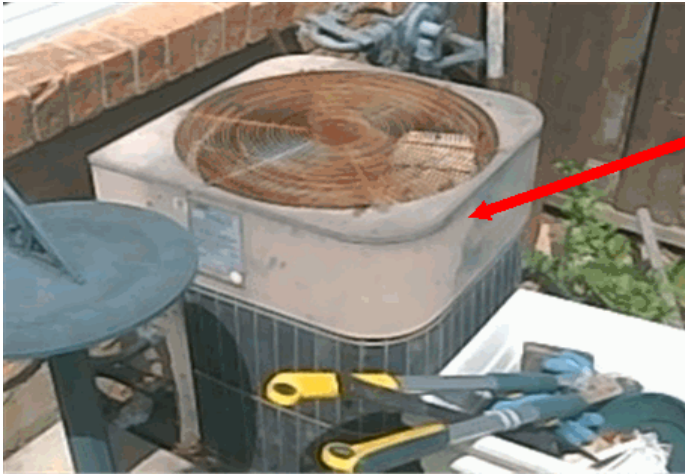
28) AC Unit Conditions

The unit appears to be past its life expectancy. Client should consider replacement with a modern unit conforming to higher efficiency standards.

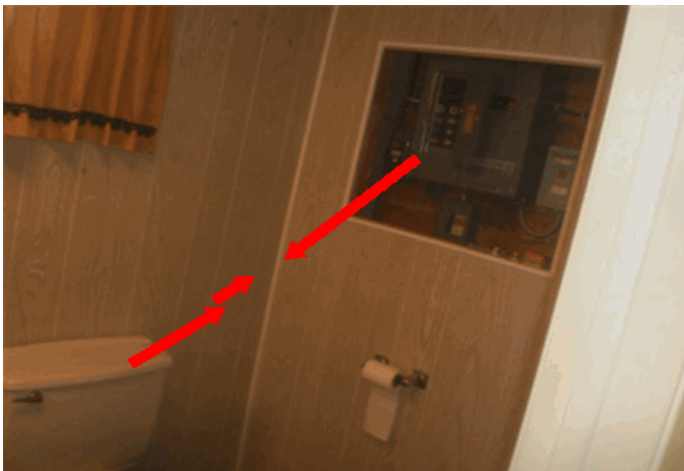
31) Electrical Panel Conditions

The electrical panel observed at basement bath. The ESA Code does not permit an electrical panel to be located in a bathroom (which is defined as a room containing bathing or showering facilities. Rule Rules 2-308, 6-206). It is suggested that a "Licensed Electrical Contractor" be contacted for further evaluation .

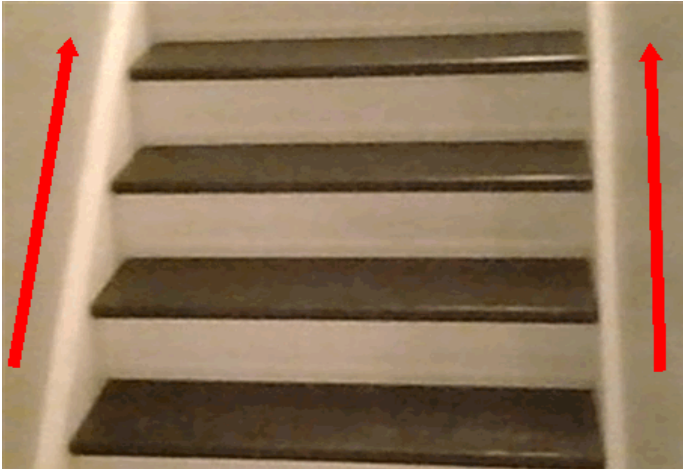
#### 32) Basement Stair Conditions

The basement stair railing was missing or not installed. Recommend installation of railings as a safety measure.

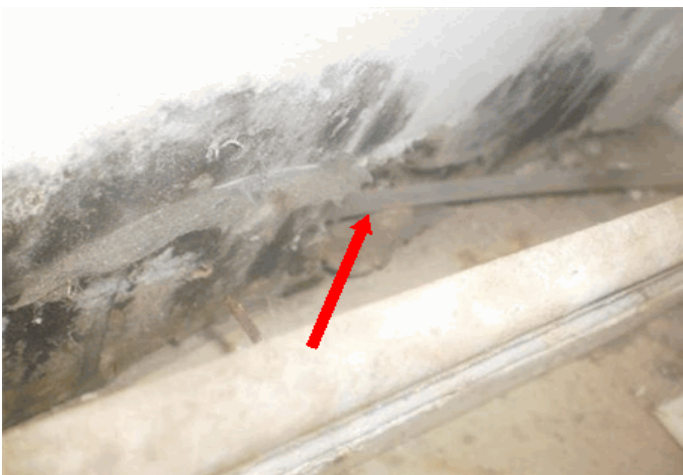
#### 33) Wall Conditions

Evidence of suspected mold was observed at basement wall due to laundry tub faucet primer tubing discharge behind drywall instead of drain. A mold inspection or testing was not performed as part of this general home inspection. Client is advised to consult a qualified mold testing company prior to closing.

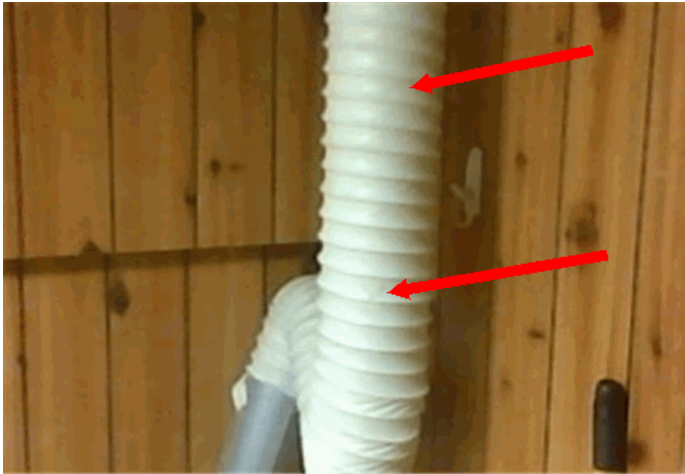
53) Laundry Room Conditions

For increased fire safety, any plastic flexible duct should be replaced with hard metal duct to reduce lint build up. The accumulation of lint can become a fire hazard. Cleaning is recommended on an annual basis.

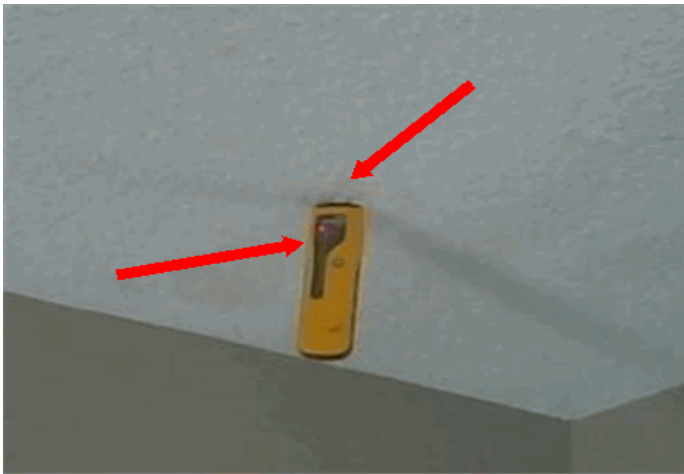
#### 76) Ceiling Conditions

Active moisture was observed at family room ceiling. Hidden damage may exist in areas not readily visible or accessible. It is suggested that a "Licensed General Contractor" be contacted for further evaluation and repair.

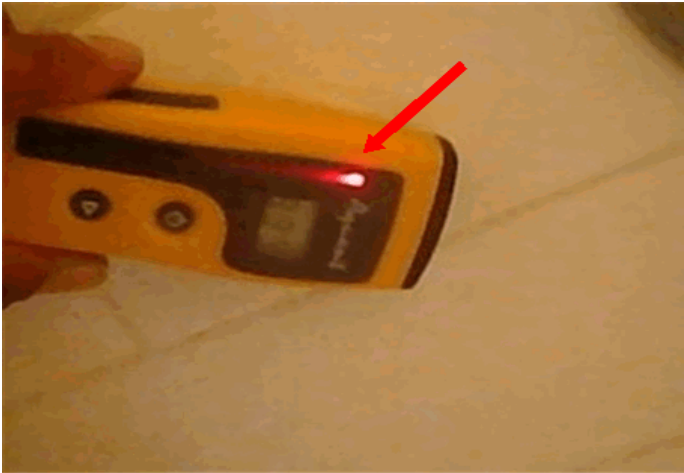
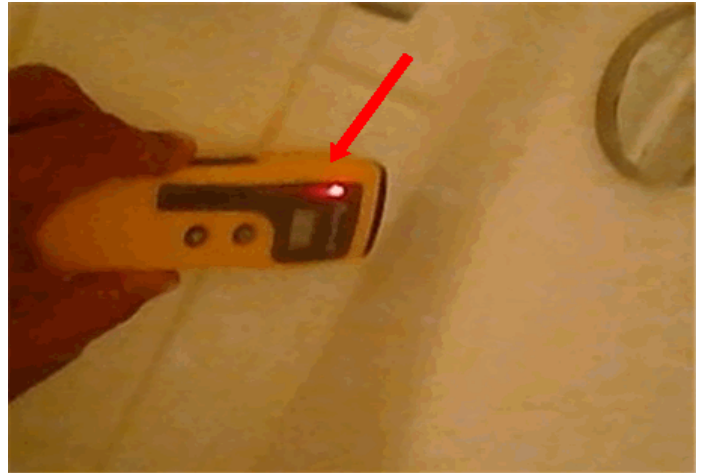
#### 99) Shower - Tub Conditions

The ensuit shower contained cracked or broken tiles in bath . Repair is recommended. Water/ moisture penetration have occurred. It is suggested that a "Licensed General Contractor" be contacted for further evaluation and repair.
